**Re: Modification (Ground-Level Windows & Courtyard) to:
Notification of TSCA Self-Implementing Clean-up of PCBs
Curtain Wall Replacement Project
JFK Federal Building
Boston, Massachusetts
ATC Job No. 060.41885.0001**

**MODIFICATION (GROUND-LEVEL WINDOWS & COURTYARD) TO
NOTIFICATION OF TSCA SELF-IMPLEMENTING
CLEAN-UP OF PCBs**

**CURTAIN WALL REPLACEMENT PROJECT
JFK FEDERAL BUILDING
BOSTON, MASSACHUSETTS**

APRIL 13, 2012

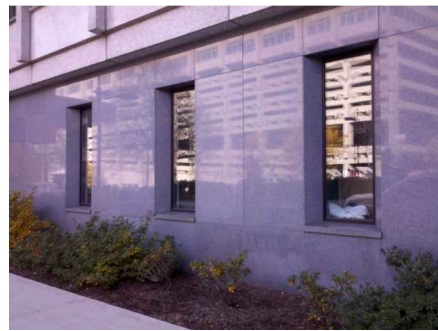
DETAIL: TYPICAL
GROUND-LEVEL WINDOWS

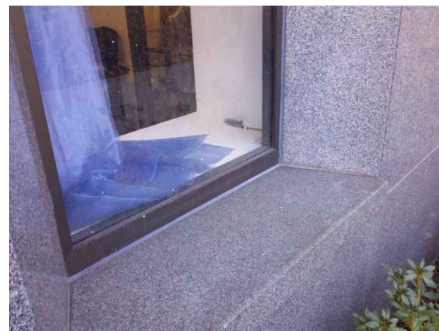
DETAIL: TYPICAL
WINDOW CLOSE-UP

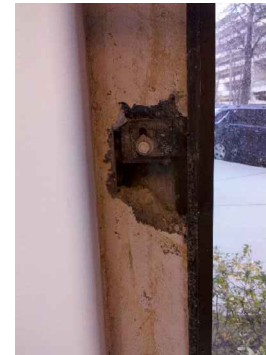
DETAIL: MORTAR IN
WINDOW G1 CAVITY

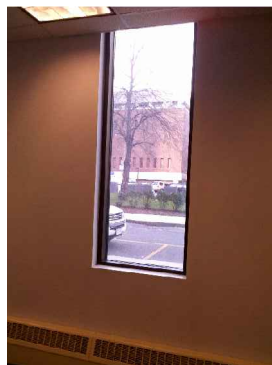
DETAIL: TYPICAL INTERIOR
WINDOW FINISHES

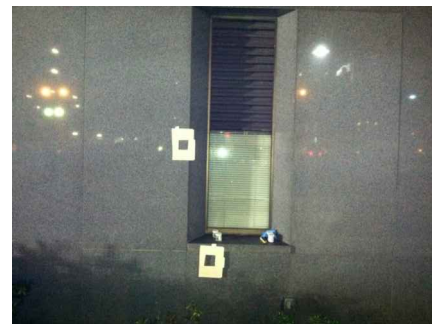
DETAIL: TYPICAL EXTERIOR
CAULK AND WIPE SAMPLE LOCATIONS

NOTE: WINDOWS
G18-G26 ON EAST
ELEVATION OF
BUILDING

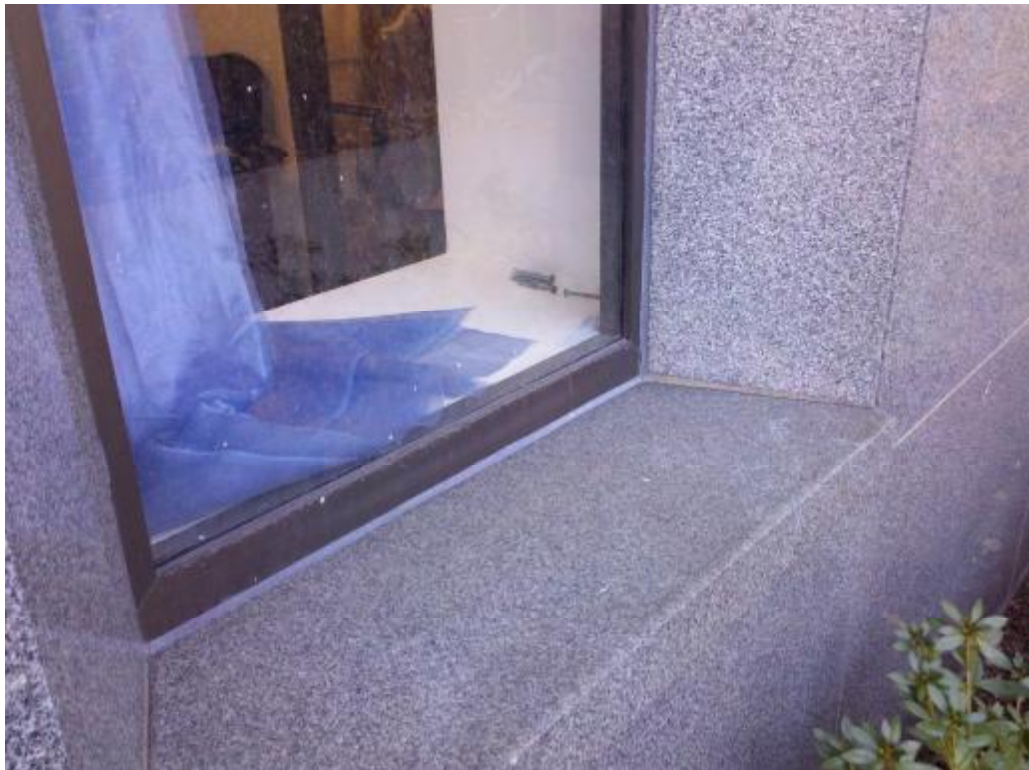
Photograph No. 2: Close-up view of Ground-Level Windows. Note gray caulk bead at edge of brown metal window frame.

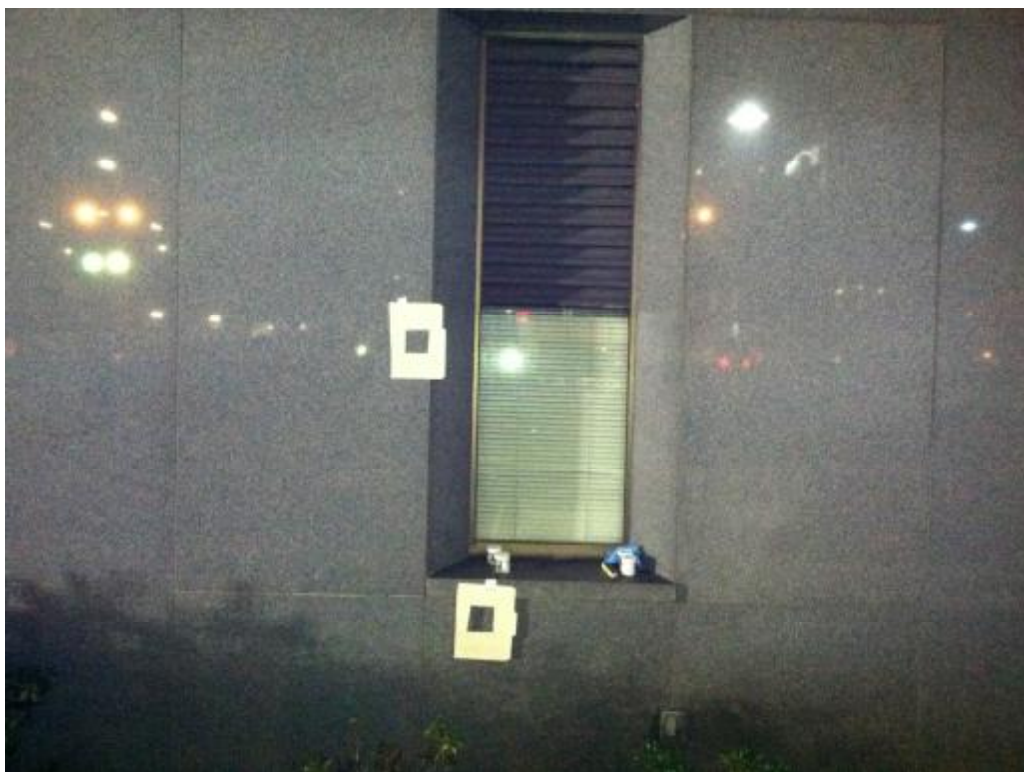
Photograph No. 3: Typical wipe sampling locations on granite façade surface.

The laboratory data for analysis of PCBs in wipe samples is presented in **Table 5**, attached. The laboratory analytical report is attached in **Appendix C**. Wipe samples were performed by ATC on non-porous building material surfaces. For the granite wall surface wipe samples, PCBs were detected in six of nine wipe samples (including the duplicate), with total PCB concentrations ranging from <0.020 to 16 ug/100 cm². Aroclor 1254 was the only Aroclor observed, which matches the Aroclor observed in the caulk, the presumed source of PCBs in wipe samples. For two out of the four ground-level windows where wipe samples were collected, the bottom sample had a higher PCB concentration than the side sample, which is consistent with precipitation washing low levels of PCBs down from the window frames. At one other window, both bottom and side wipe PCB concentrations were non-detectable, and at the fourth window, the side wipe PCB concentration was very low (0.21 ug/100 cm²) while the bottom wipe concentration was non-detectable. Only one wipe sample (G2-Wipe-Bottom, at 16 ug/100 cm²) contained a

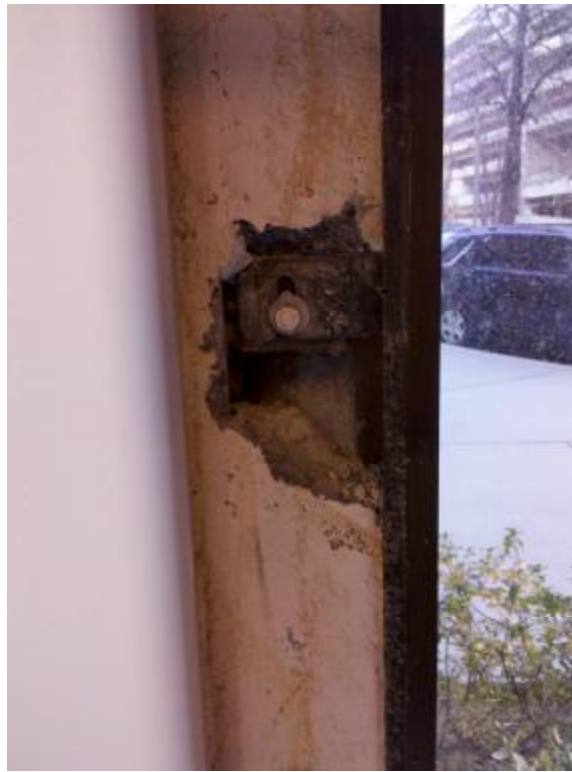
The cavity at window G1 contained mortar filler. A picture of the mortar in the window cavity is attached in **Appendix A**. A small amount of mortar extends into the small 1/8- to 1/4-inch space between the window frame flange and the exterior granite window surround, but not in all locations. This mortar is in close proximity to the exterior caulk which is an estimated two inches beyond the interior edge of the window frame flange. The cavity at 10 other windows that were inspected by ATC either contained loose insulation (windows G6 through G12) or was empty. The cavity is enclosed on the interior with drywall.

The laboratory data for analysis of PCBs in interior window cavity mortar (ground-level window G1 only) are presented in **Table 3**. The laboratory analytical report is provided in **Appendix C**. PCBs were detected in the mortar samples, with detected total PCB concentrations ranging from 0.86 to 17 mg/kg (ppm). The highest concentration was observed at a distance of one inch into the window void from the edge of the window frame flange. The concentration behind the flange (near the exterior caulk) and at a distance of three inches from the flange in the window void were similar, at approximately 7 ppm. Aroclor 1254 was the only Aroclor observed, which matches the Aroclor observed in window caulk, the presumed source of PCBs in cavity mortar. ATC assumes that the mortar has become contaminated from the exterior caulk, and would therefore be considered a PCB Remediation Waste.

Photograph No. 5: View of mortar filling window cavity at window G1. Note mortar was removed in center of photograph during inspection. No other inspected window had this mortar filling.

The cavity material waste generated under this task will be managed as a PCB Remediation Waste with PCBs <50 ppm, as described in Section 4.2. All other interior building materials are not near or exposed to PCB-containing caulk and will be managed as general demolition debris. Tools used to remove the cavity material will either be decontaminated at the end of work or disposed of as PCB Remediation Waste. Loose wastes generated under this task shall be transported from location of generation to the waste containers/dumpsters in minimum 6-mil doubled plastic bags.

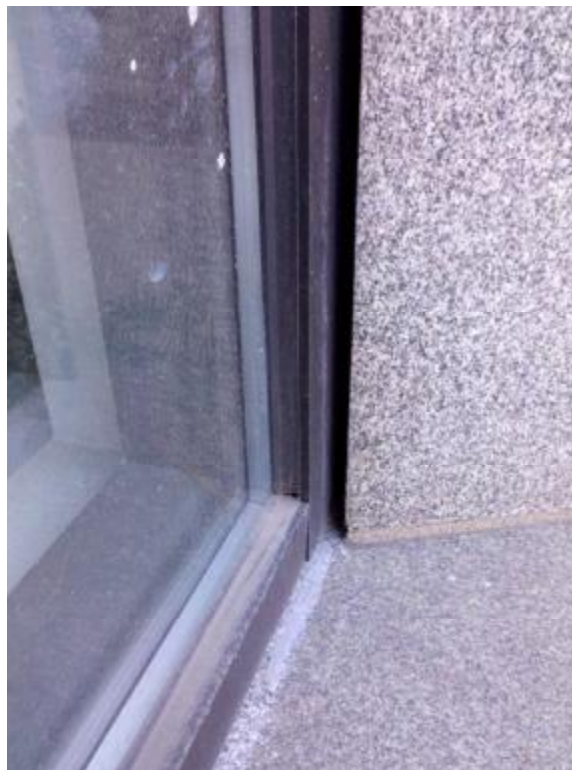
The exterior caulk between the metal window frames of the ground-level windows and granite window surround is smooth and rubbery, dark gray in color, and appeared to be the same material at each ground-level window. In three windows (G3, G4, and G5) the caulk appears to have been removed at some point in the past and not replaced.

Photograph No. 6: Missing caulk at one window. Note caulk residue at base of window.

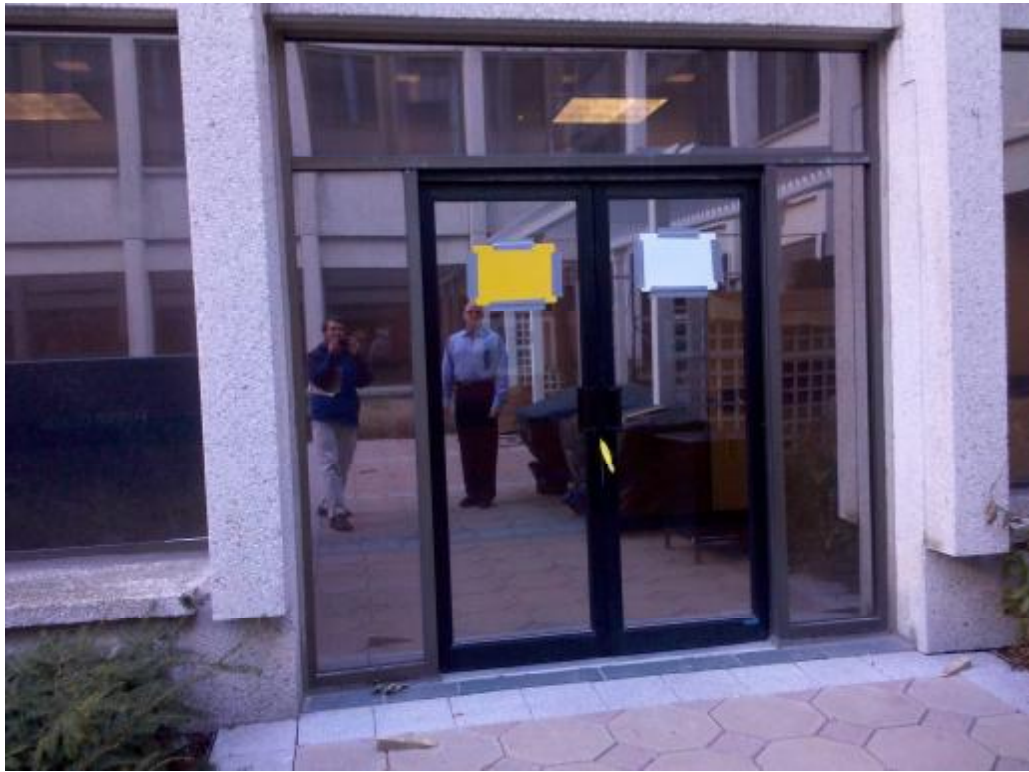
Photograph No. 1: Typical doorway leading into inner courtyard. Two of these doorways exist on south side elevation of courtyard. Frame/Concrete caulk bead is between edge of metal window frame and adjacent concrete wall.

At the two doorways that are being replaced on the 1st floor, gray stone or masonry pavers are located within two feet of a caulk joint. Based on their limited quantity, these pavers are assumed to contain PCBs > 50 ppm, and will be removed and disposed as PCB Remediation Waste > 50 ppm. Red pavers located beyond the gray pavers were sampled and found to contain PCBs <1 ppm.

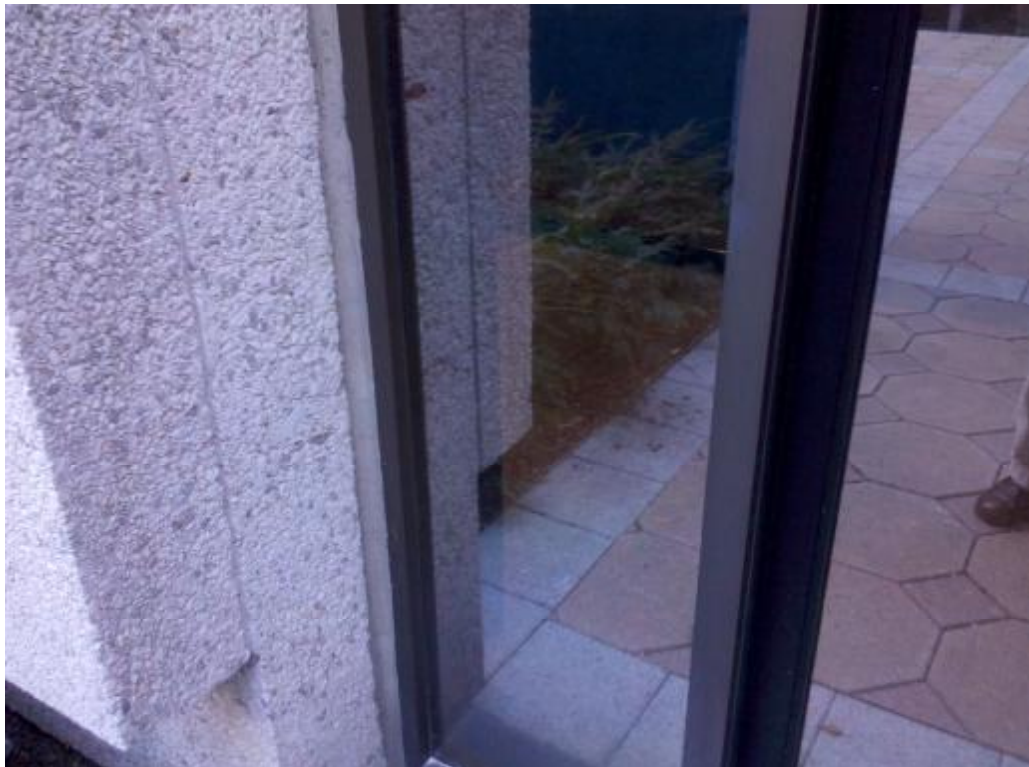
Photograph No. 2: Close-up view of doorway leading into inner courtyard. Note light gray caulk bead between metal window frame and concrete wall.

- 4) Decontaminate or remove a layer of the surface of the concrete wall beneath and within six inches of the Frame/Concrete caulk bead to achieve a maximum remaining concentration of PCBs in concrete of 25 ppm. Confirmation bulk samples will be collected to ensure that remaining PCB concentrations in the concrete are \leq 25 ppm.
- 5) At the 2 doorways that are being replaced, remove dark gray stone pavers on the exterior next to doorway wall and the first row of light gray masonry pavers beyond the dark gray stone pavers, and dispose as PCB Remediation Waste. Also remove the metal threshold beneath the door and dispose as PCB Remediation Waste.
- 6) Install new windows.
- 7) Include restrictions specific to some areas of the courtyard windows where PCBs will remain in concrete in the deed notice already planned to be filed for the property with the Registry of Deeds.

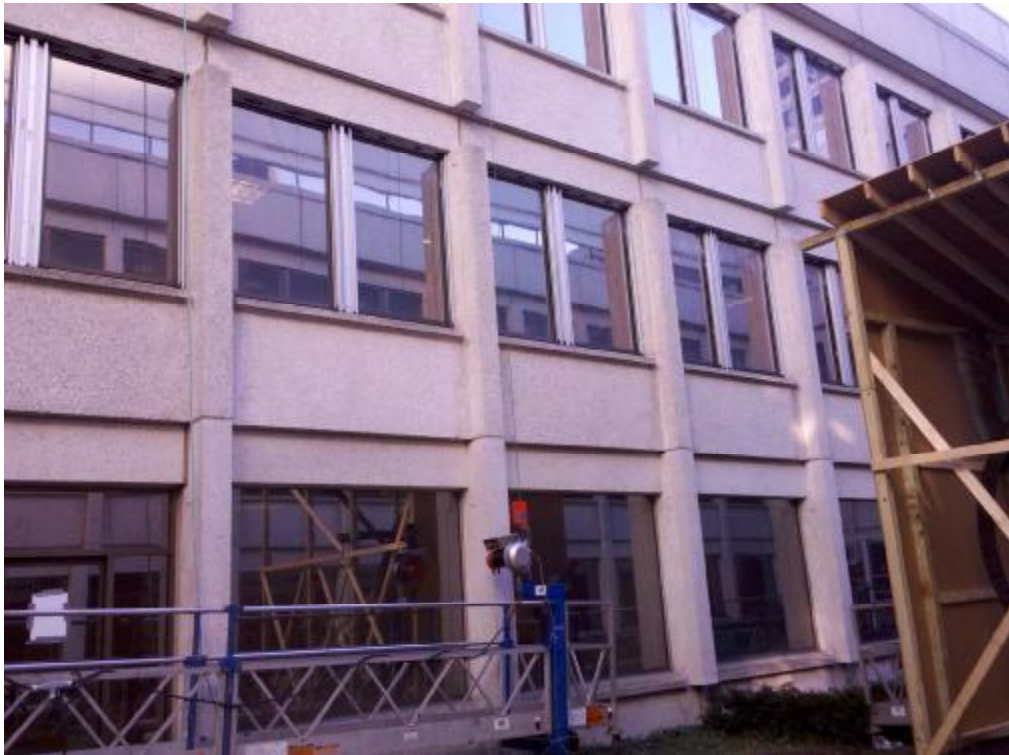
On January 12, 2012, ATC collected a total of seven samples from caulk sealant materials beneath metal trim molding on the interior perimeter of courtyard windows on the 1st floor level. These 1st floor windows are constructed slightly differently than 2nd and 3rd story courtyard windows, and have caulk/sealants that will be disturbed when the old trim “stops” and glass panes are removed (see photograph in **Appendix B**). Contractors for the window project were present to remove the trim stops. Samples of each material observed were collected from one window in each of the west, north, and south elevations of the courtyard (Locations #8, #9, and #10), as shown on **Figure 6**. The two types of caulk/sealant materials sampled are described in **Table 1**.

Photograph No. 3: View of north elevation of courtyard, showing the 1st floor courtyard windows where two types of interior caulk/sealants around the window perimeters contain PCBs.

Caulk/sealant waste generated will be managed as a PCB Bulk Product Waste, as described in Section 4.2. Some of the caulk materials will also be managed as an asbestos waste. Loose wastes generated under this task shall be transported from location of generation to the waste containers/dumpsters in minimum 6-mil doubled plastic bags.

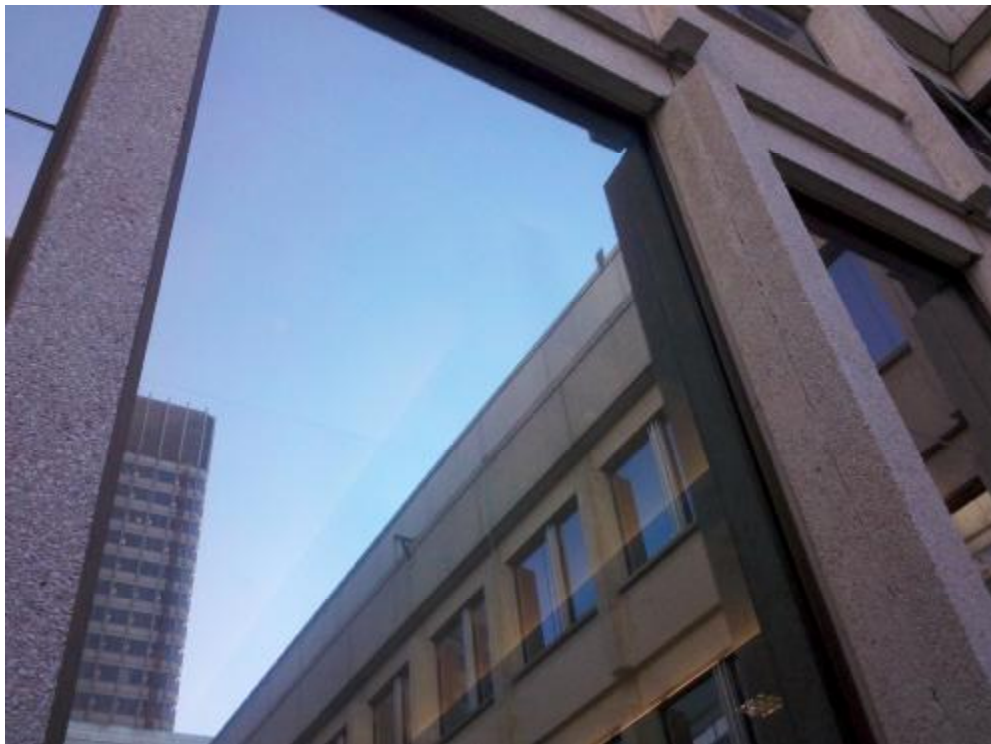
Photograph No. 4: View of east elevation "tall windows" that span the 1st and 2nd floors. There is Frame/Concrete caulk around the perimeter of each window, and glazing sealant between glass and frames on both interior and exterior.

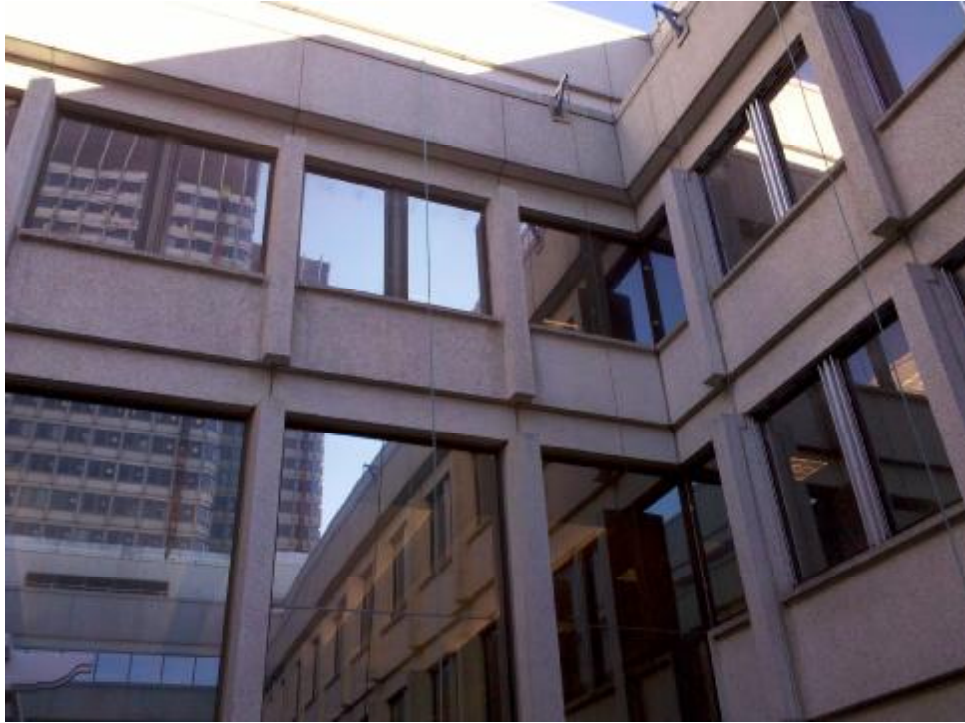
Photograph No. 5: View of southeast corner of courtyard. Note how east elevation tall windows butt up against south elevation side windows in some locations, with no intervening concrete surface. The Frame/Frame caulk is between the frames on the edges of these two windows.

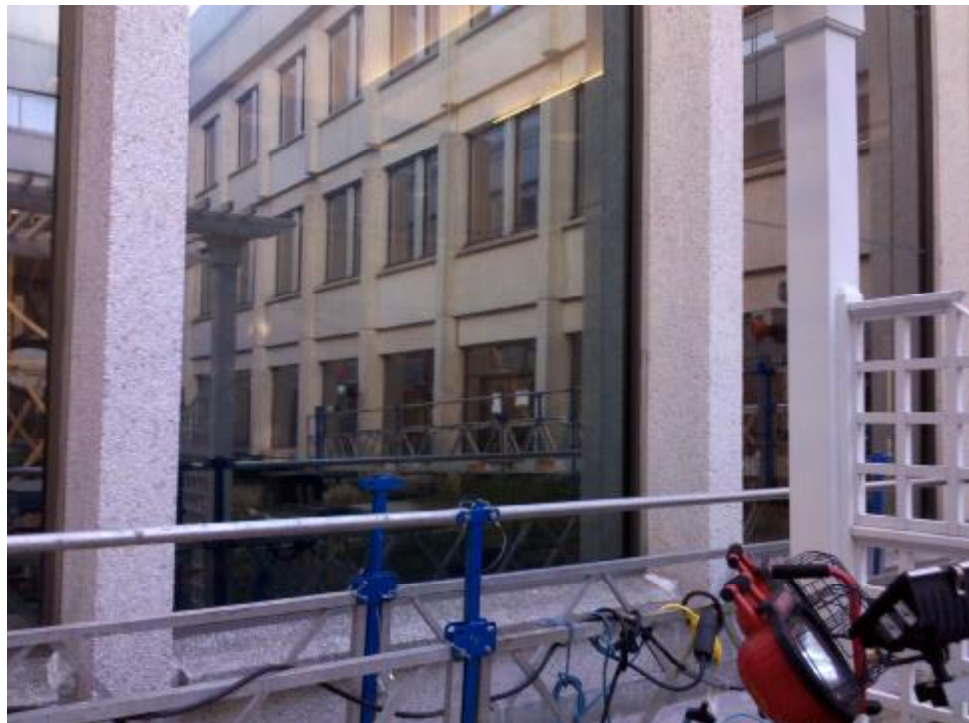
Photograph No. 6: View of bottom of east elevation tall windows.

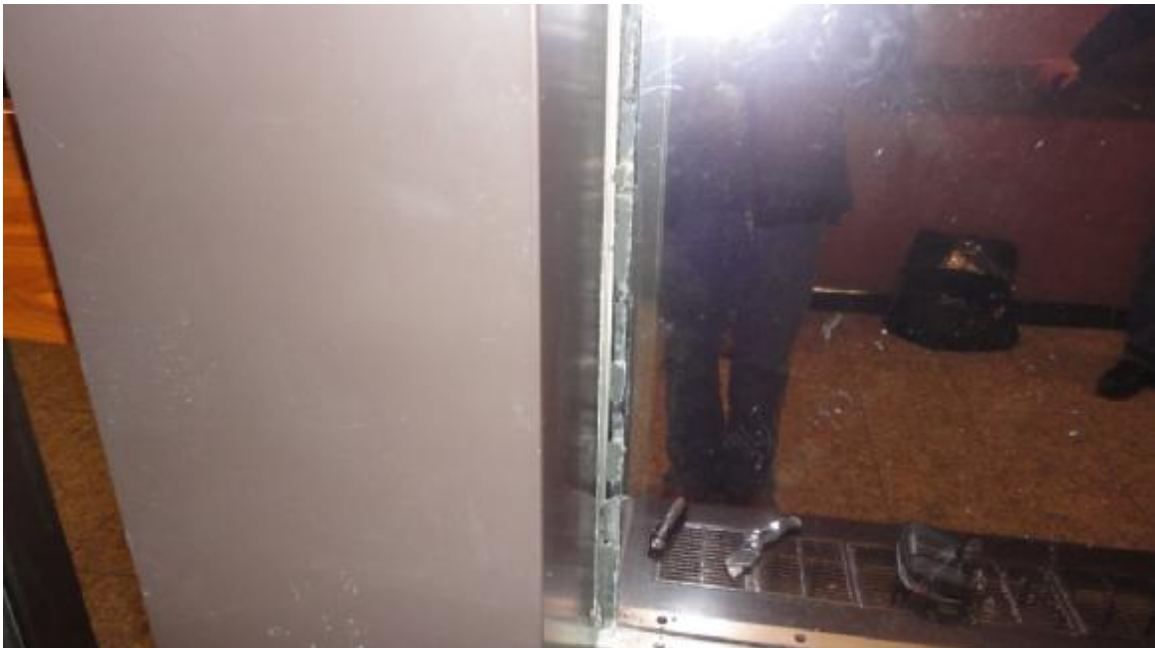
Photograph No. 8: View of interior of 1st floor courtyard windows. Note gray brittle trim sealant at edge of glass pane after trim "stop" was removed.

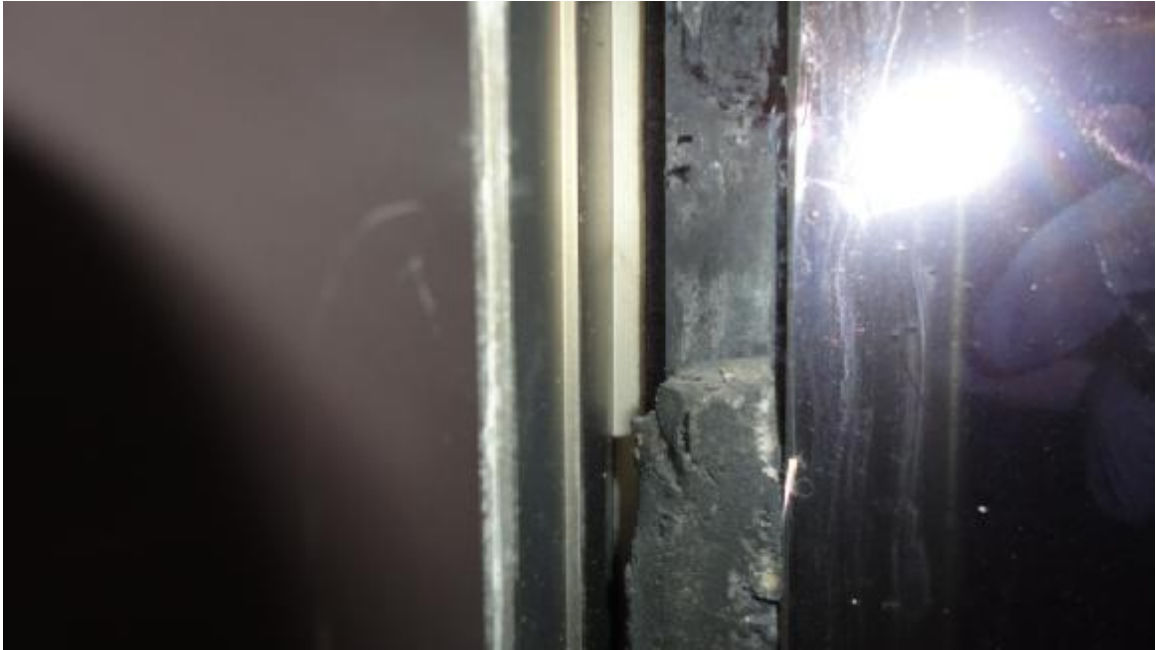
Photograph No. 9: Close-up view of interior of 1st floor courtyard windows. Note gray brittle trim sealant at edge of glass pane after trim “stop” was removed. Black sticky caulk/sealant was located at edge of glass pane, as well as on the outside surface of the pane near the edge.

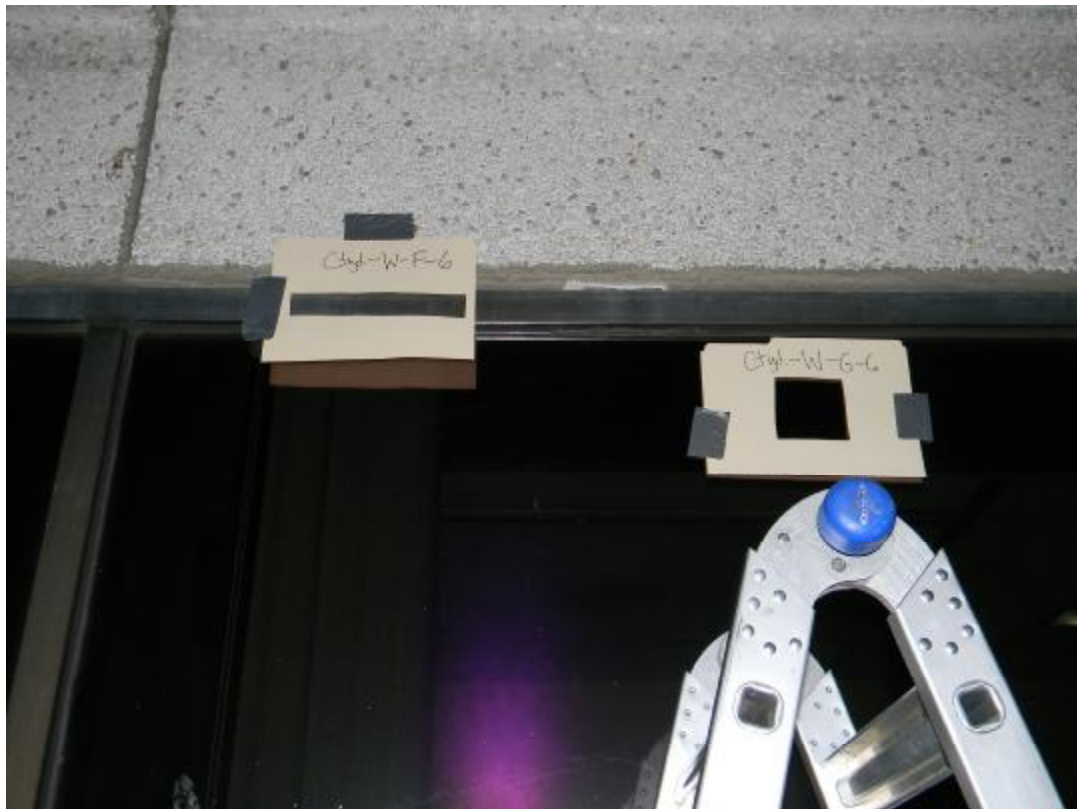
Photograph No. 10: Typical complete sample set (#6 on 4th floor level). Note caulk sample location between two wipe sample locations. Concrete samples were collected going up from caulk bead after caulk and wipe samples were collected.

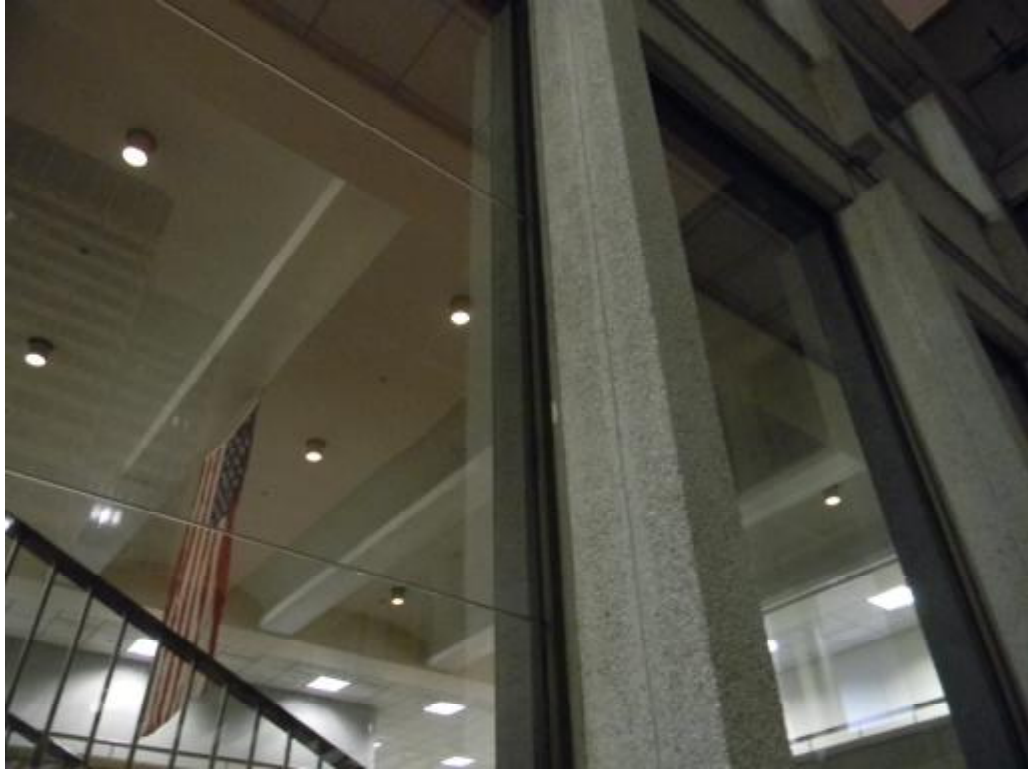
Photograph No. 11: Sample Location #1 on east elevation tall window.

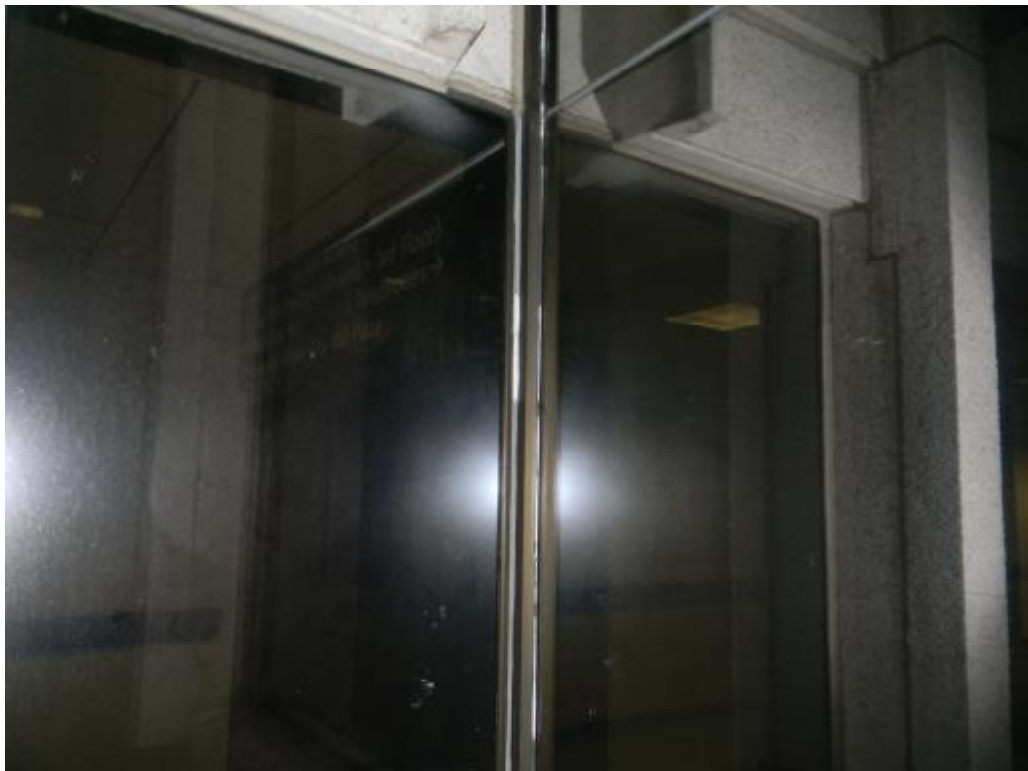
Photograph No. 12: Sample Location #2 at northeast corner of courtyard. Note two abutting frames in center where Frame/Frame caulk sample was collected.

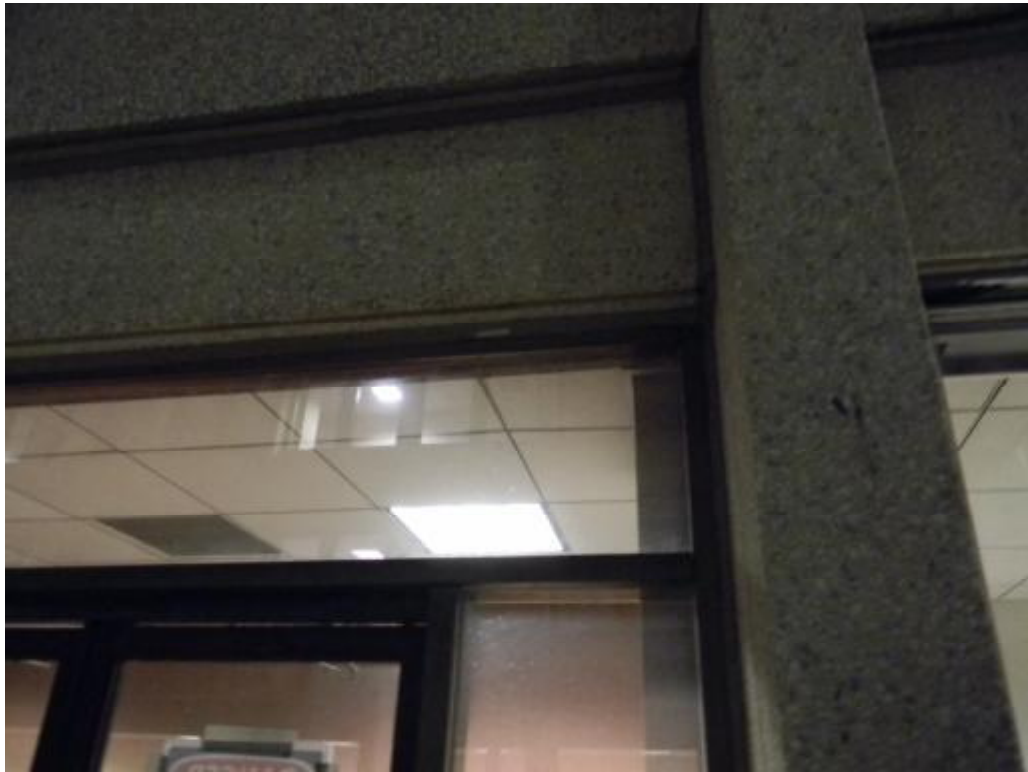
Photograph No. 13: Sample set Location #4 above western doorway in south elevation wall.

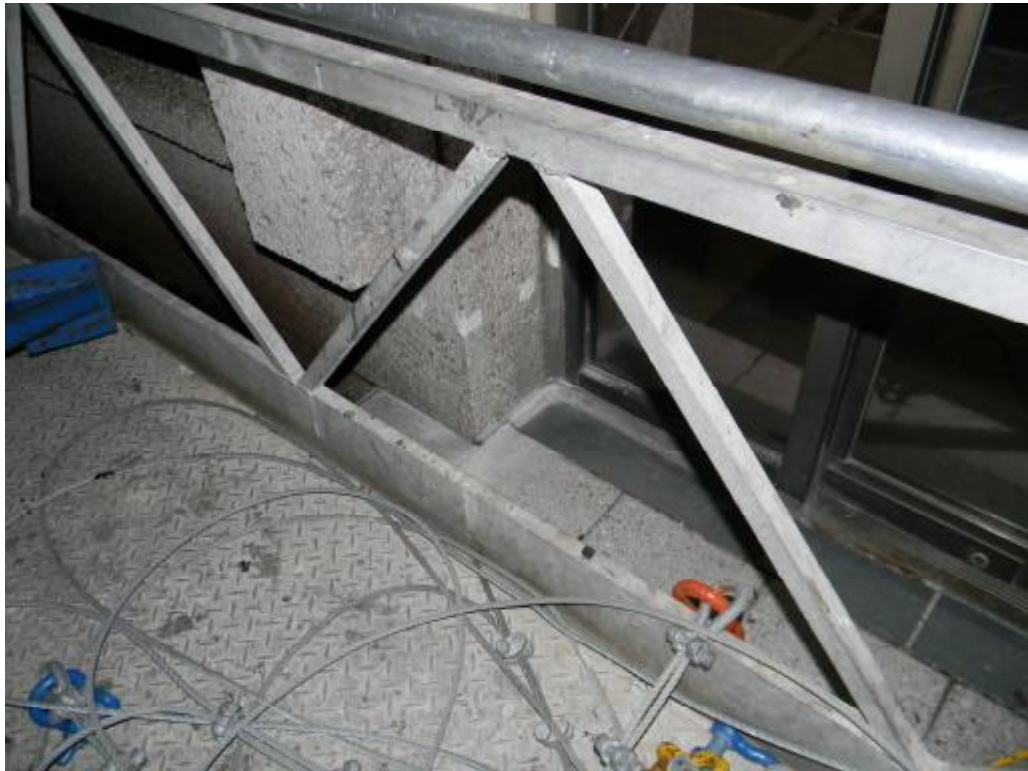
Photograph No. 14: Sample set Location #5 at side of eastern doorway in south elevation wall.

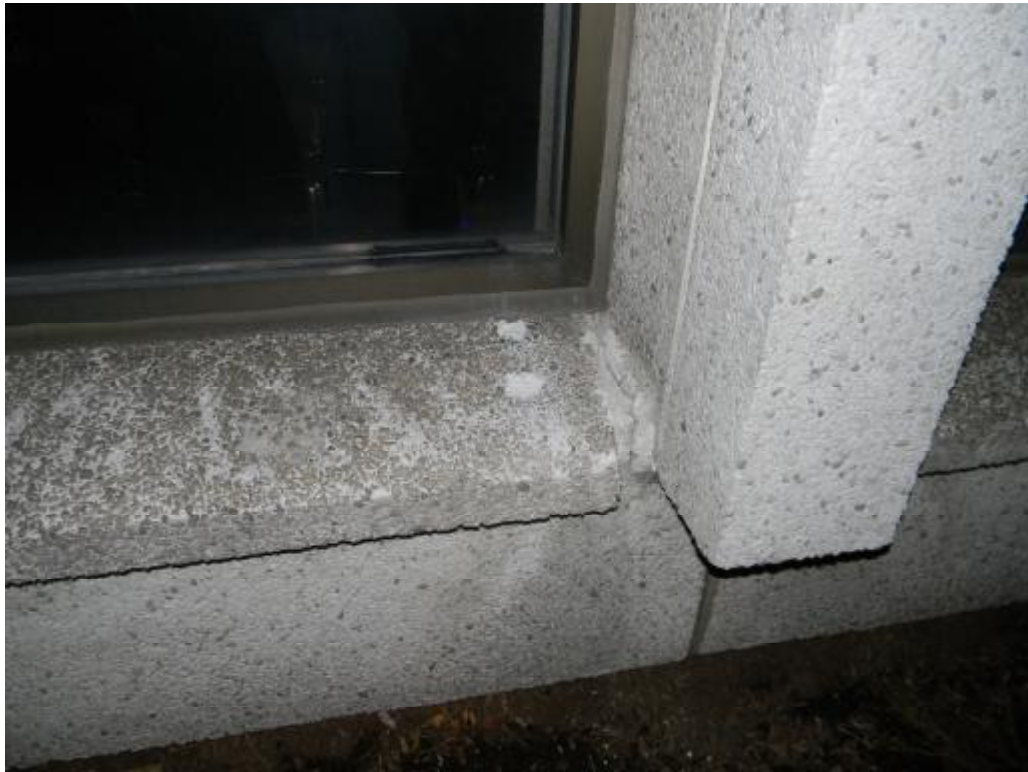
Photograph No. 15: Sample set Location #3 at bottom of eastern elevation window.
